# Summary of Performance Analyses of a Santa Clara County Facility by CEE 243 Student Groups

Tom Abraham, John Kunz, James O'Donnell, Matt Garr

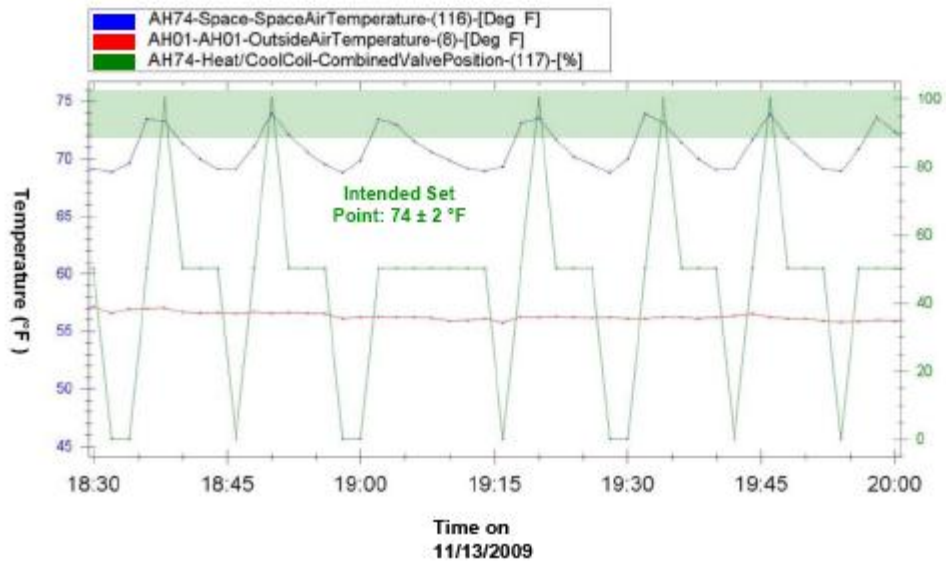
Period of October and November 2009 required more frequent cooling than summer months. On November 13, 2009, system quickly alternated between heating and cooling.

Figure 1: AH74 lobby space air temperature, heating/cooling valve position, and OAT on November 13, 2009, showing heating and cooling cycles

<b>Recommendations</b>	<p>Set point range does not seem to be 74±2°F. Investigate what set point is intended and/or acceptable for these spaces.</p> <p>Investigate whether a wider dead band would be tolerable to prevent summer heating, winter cooling, and frequent cycling between heating and cooling.</p> <p>Investigate when these spaces are occupied and whether the dead band can be increased during times of vacancy.</p> <p>System neither heats nor cools for a majority of the time, which in conjunction with the wide space air temperature could indicate a malfunctioning valve or sensor.</p> <p>Physically investigate to determine whether the valves are functioning properly.</p> <p>Occupancy sensors would help explain abnormal spikes or temperature decreases.</p> <p>Consider installing fan sensors with constant monitoring to determine whether there is missing data or the system was unchanged.</p> <p>Confirm whether sensors that should output binary signals (supply and return fan sensors) are truly binary; otherwise determine what would cause non-binary readings.</p>

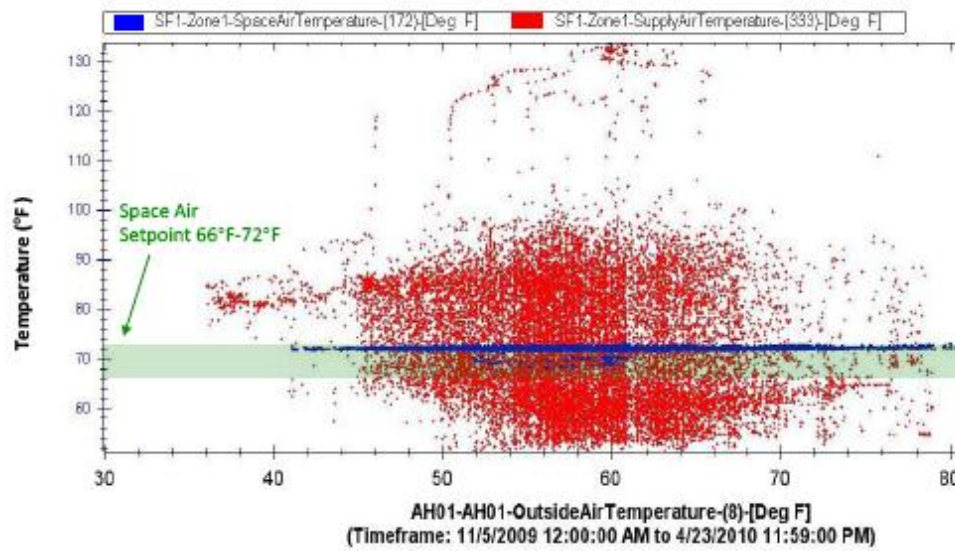
Zones 1-6  
 Space air temperature only within the intended set point range during a brief period in December 2009. No correlation between decrease in space air temperature and OAT.  
 Zones 1-4  
 Supply air temperatures for zones 1 through 4 fluctuate radically from about 50°F to 130°F for almost all OATs. The difference between supply and space air temperature is +60°F and -20°F for a given OAT, while the space air temperature remains very constant.  
 Cooling and heating are occurring almost simultaneously resulting in a clear indication of energy waste.  
 Heating is occurring during warmer spring months and cooling is occurring during cooler winter months.

Figure 2: Supply air temperature for Zone 1 of SF1 as OAT varies from November 4, 2009 through April 22, 2010. Note the extreme fluctuation in supply air temperature and lack of correlation to OAT, while space air temperature is extremely constant

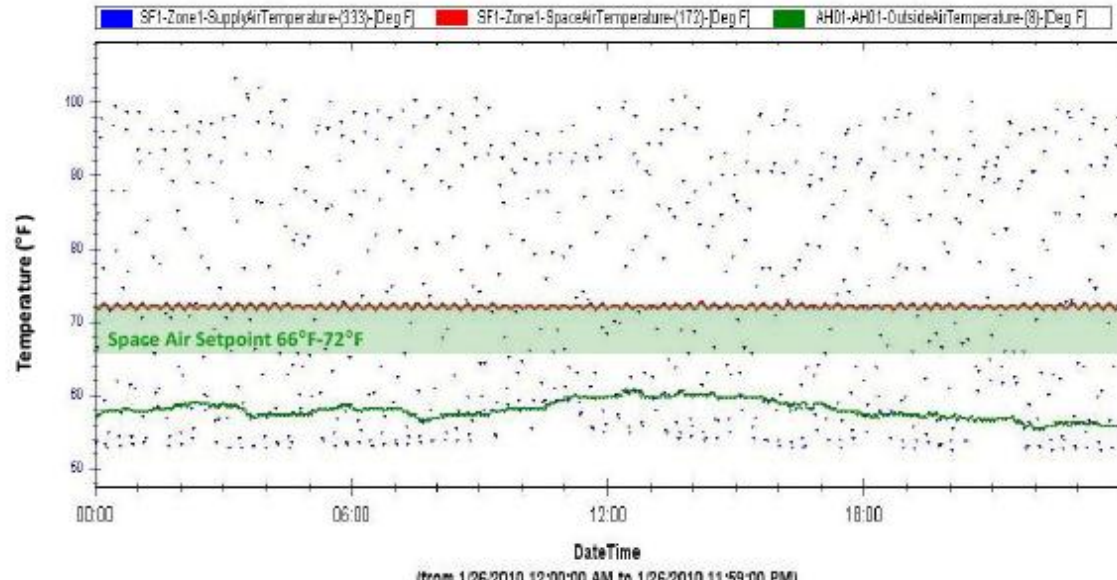
Figure 3: An illustrative example of space 1 on January 26, 2010, showing the near simultaneous temperature fluctuation of supply air temperature as OAT and space air temperature remain fairly constant

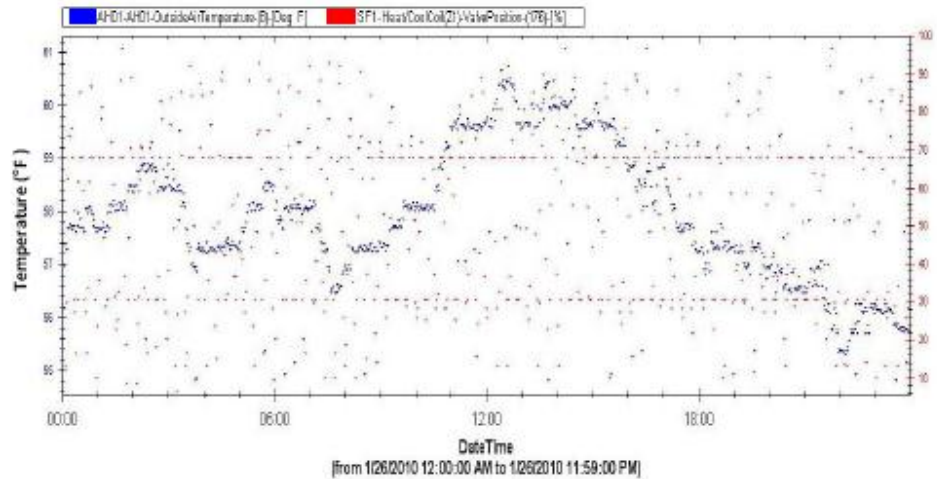
Figure 4: An illustrative example of space 1 valve position on January 26, 2010 (0% being full heating, 50% being neither heating nor cooling, and 100% being full cooling), showing the near simultaneous heating and cooling. Also note that cooling is occurring on a winter day when the OAT is less than 60 °F

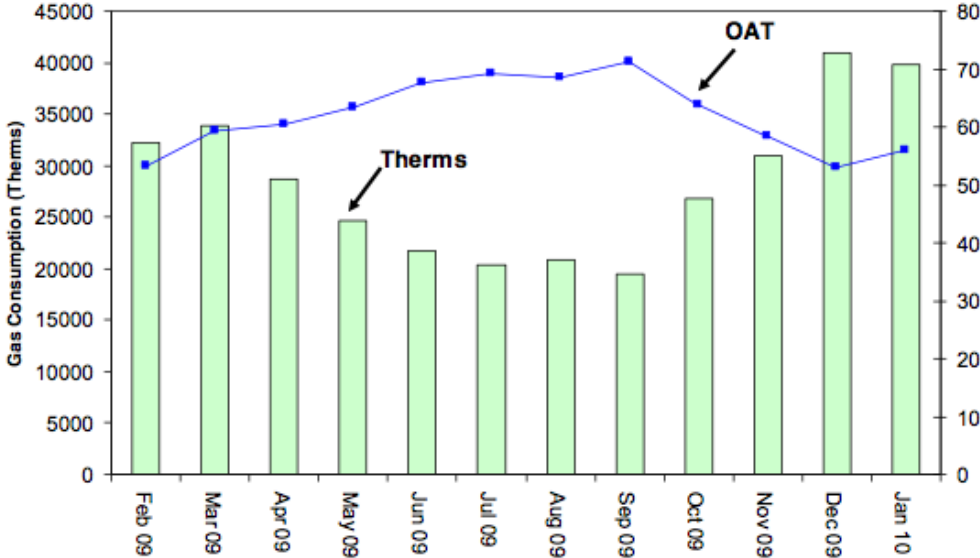
<p data-bbox="472 1010 1468 1207">Monthly natural gas consumption data (therms) for the SCC facility was available from February 2009 through January 2010. The total gas consumption for this 12-month period was 340,170 therms. The average OAT for each month was overlaid on monthly gas usage, as shown in the figure below. As expected, the therm usage is negatively correlated to the average OAT; the monthly therm usage is greater for months with a lower average OAT, and vice versa.</p> <p data-bbox="690 1226 1252 1255" style="text-align: center;"><i>Figure 5: Whole Building Natural Gas Consumption</i></p> <p data-bbox="472 1274 1468 1371">Monthly therm usage increases when OAT decreases because space heating is likely the largest therm end-use in the facility. The hot water loop system, which heats the air, thus has the largest impact on therm usage of the building.</p>

<b>Problem Areas</b>	<i>Editor's Note: Summer natural gas usage is substantial and must be explored.</i>
<b>Recommendations</b>	<p data-bbox="472 1434 1468 1570">As the performance of the hot water loop is improved and simultaneous heating and cooling in the facility is eliminated using better control schemes, gas consumption is expected to decrease, potentially yielding significant financial savings</p> <p data-bbox="472 1581 1468 1682">Domestic hot water is also on the same gas meter, but the domestic hot water demand is not known from the data available, and thus the therms usage attributed to domestic hot water cannot be estimated.</p> <p data-bbox="472 1692 1468 1904">The natural gas loads for each subsystem can be determined through a detailed analysis of the subsystem. However, this was not carried out in this project due to the complexity of operation observed and the number of zones. In the future, this load calculation could be carried out to determine if the sum of the heating loads for each subsystem equal the total gas consumption of the facility.</p>

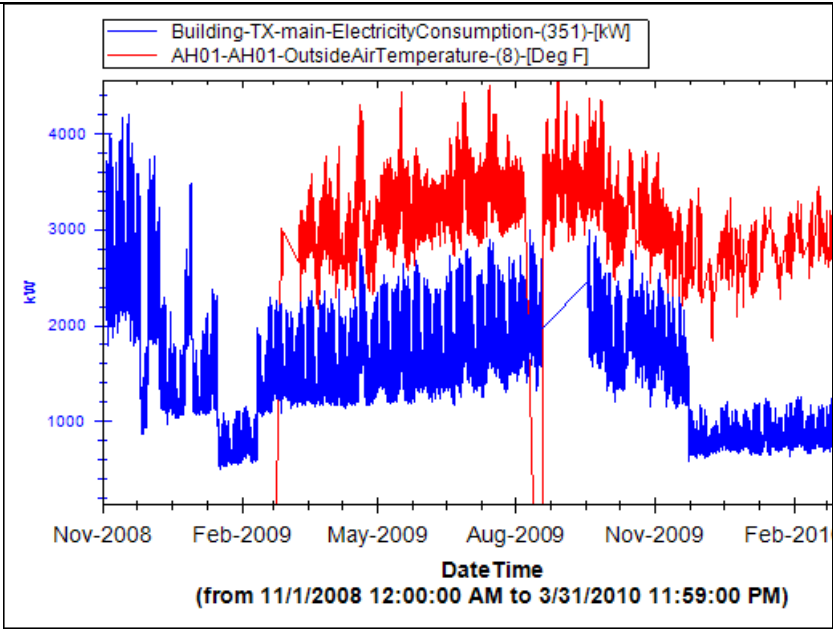
Figure 7: Whole Building Hourly Electricity Consumption

Since this meter measured several facilities, it is difficult to determine what portion is actually associated this facility.

<b>Recommendations</b>	<p>Install a separate meter to measure the electricity consumption just in this facility. Confirm whether major pieces of equipment are being shut down during the winter season. If so, it appears that these units have major energy conservation potential while in operation.</p> <p>Determine the specific systems on the submeters for additional analysis. It would be useful to submeter specific areas or systems, such as the chillers, lights, and fans.</p>
------------------------	---

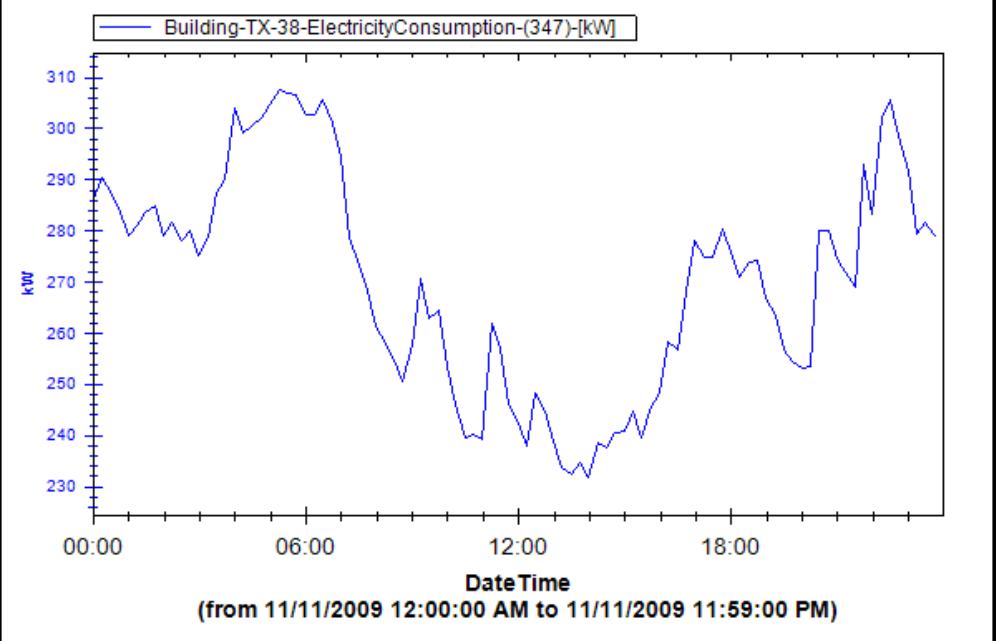
Figure 8: Submeter TX-238 Electricity Consumption on 11/11/09

Submetered data was available, but it is unknown which pieces of equipment are on each submeter. Electricity consumption on the submeters was relatively small and fairly constant throughout the year. There were evident daily patterns in the submeters, but their meanings were not intuitive. For example, meter TX-38 would oftentimes peak in the early morning.
